U.S. Department
of Transportation
**Federal Aviation
Administration**

Aviation Maintenance Alerts

**ALERT NO. 257
DECEMBER 1999**

**Improve Reliability-
Interchange Service
Experience**

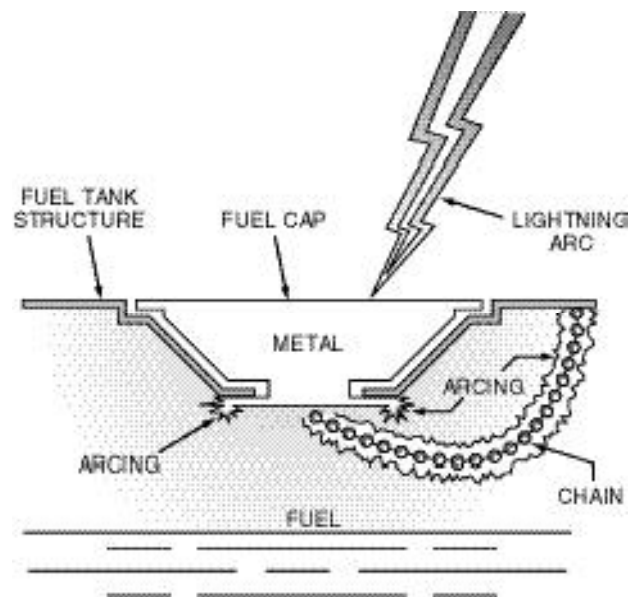
The FAA discourages the use of metallic fuel cap retention and encourages the use of nonmetallic, fuel-resistant devices. These nonmetallic fuel cap retainers provide greater lightning protection, especially for float-equipped and high-wing aircraft. (Refer to the following illustration.) We encourage aircraft manufacturers and aftermarket suppliers to provide only nonmetallic, fuel-resistant fuel cap retainers which do not contribute to electrical arcing.

Metallic cap retainers installed by the manufacturer may be removed and replaced by a nonmetallic retainer. This action constitutes a "minor alteration" and should be accomplished in accordance with 14 CFR part 43.
